Re: August 2016 Monthly Progress Report
Administrative Settlement Agreement and Order on Consent for Removal Action
U.S. EPA Region 10 Docket No. CERCLA 10-2009-0255
Gasco Sediments Site within the Portland Harbor Superfund Site

Attachment A Monthly Visual Monitoring Report for Pilot Cap Vicinity

Visual Observations Log Form

Monitoring Period: Monthly (Year 10)— August 2016

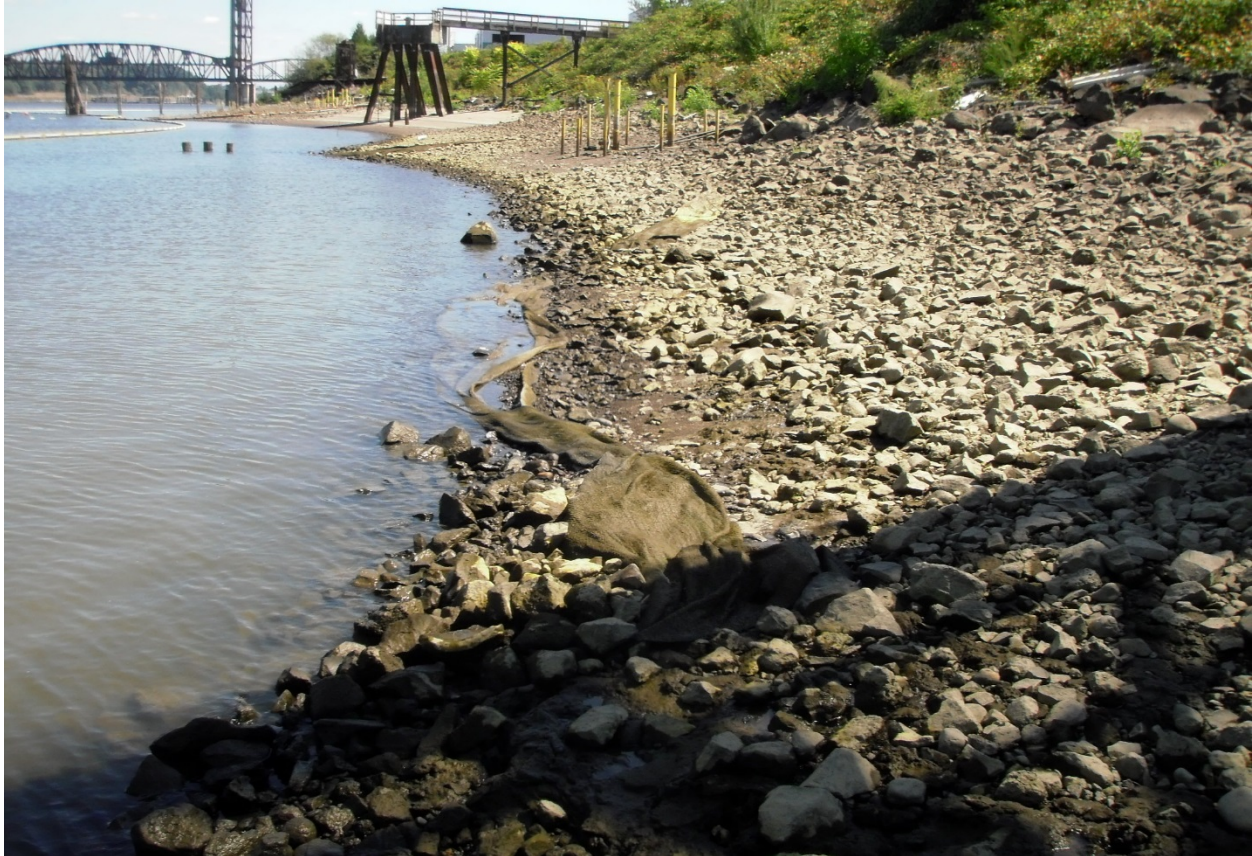
Observations of Erosion/Deposition: No erosion/deposition was evident along the shoreline. All previously noted organo-clay mat material segments are visible. A segment 5 feet in length is out of the water approximately 7 feet from the water's edge, near the lateral mid-point of the cap area. A 15-foot section is shoreward of the water's edge, perpendicular to the shoreline at the upriver boundary of the cap area. A section of organo-clay mat material measuring 40 feet in length is exposed near the downriver extent of the cap at the water's edge (Photo 1).

Photo 1 — *Mat material visible at the downriver extent of the cap area. 8/10/16):*

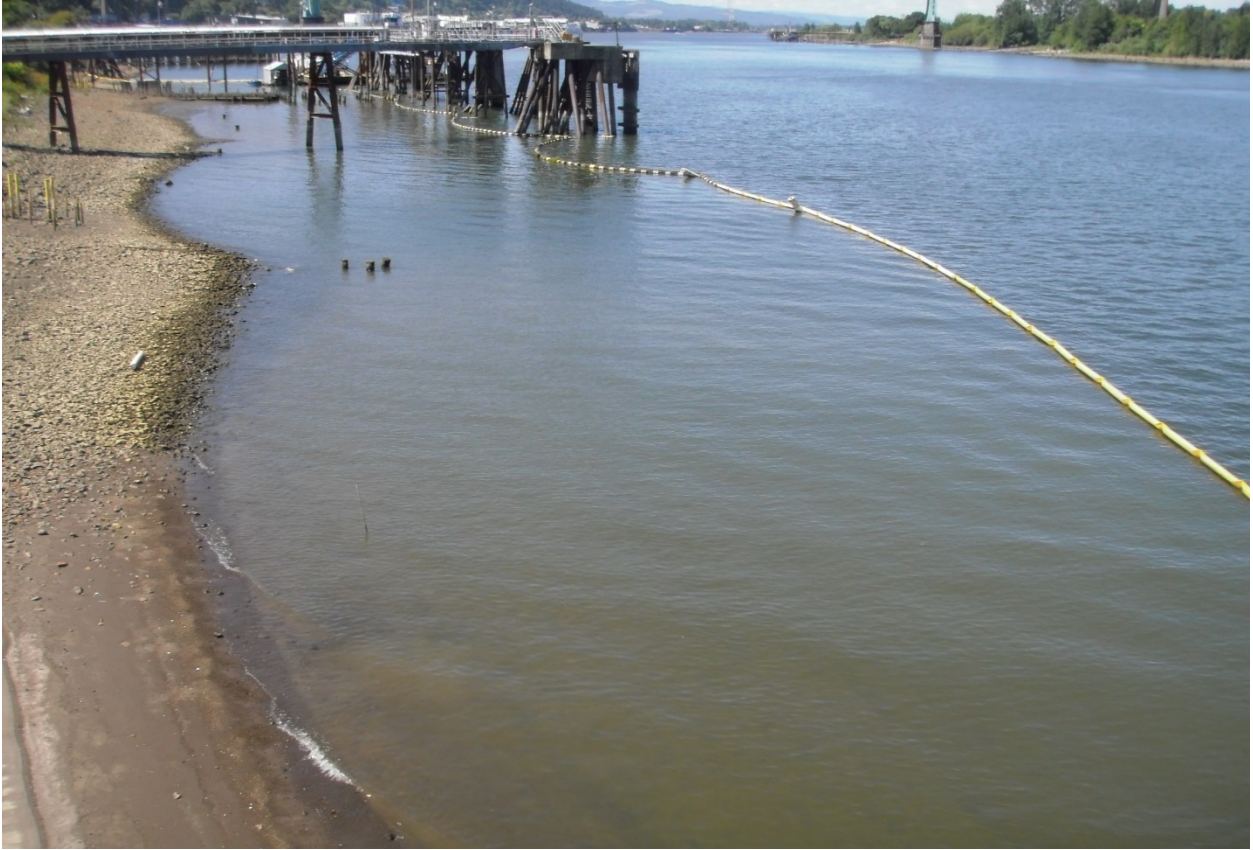
Observations of Long-term Controls (i.e., oil booms, organo-clay mat, etc.) During the observation, the FAMM containment boom was in place across the cap area from the ship dock to an anchor point riverward of the upriver dolphin. Two buoys that identify the cap area to mariners were in place as installed. The position of the FAMM oil boom and warning buoys is shown in Photo 2.

Photo 2 — *FAMM oil boom placement and mariner warning buoys at pilot cap area. (8/10/16):*

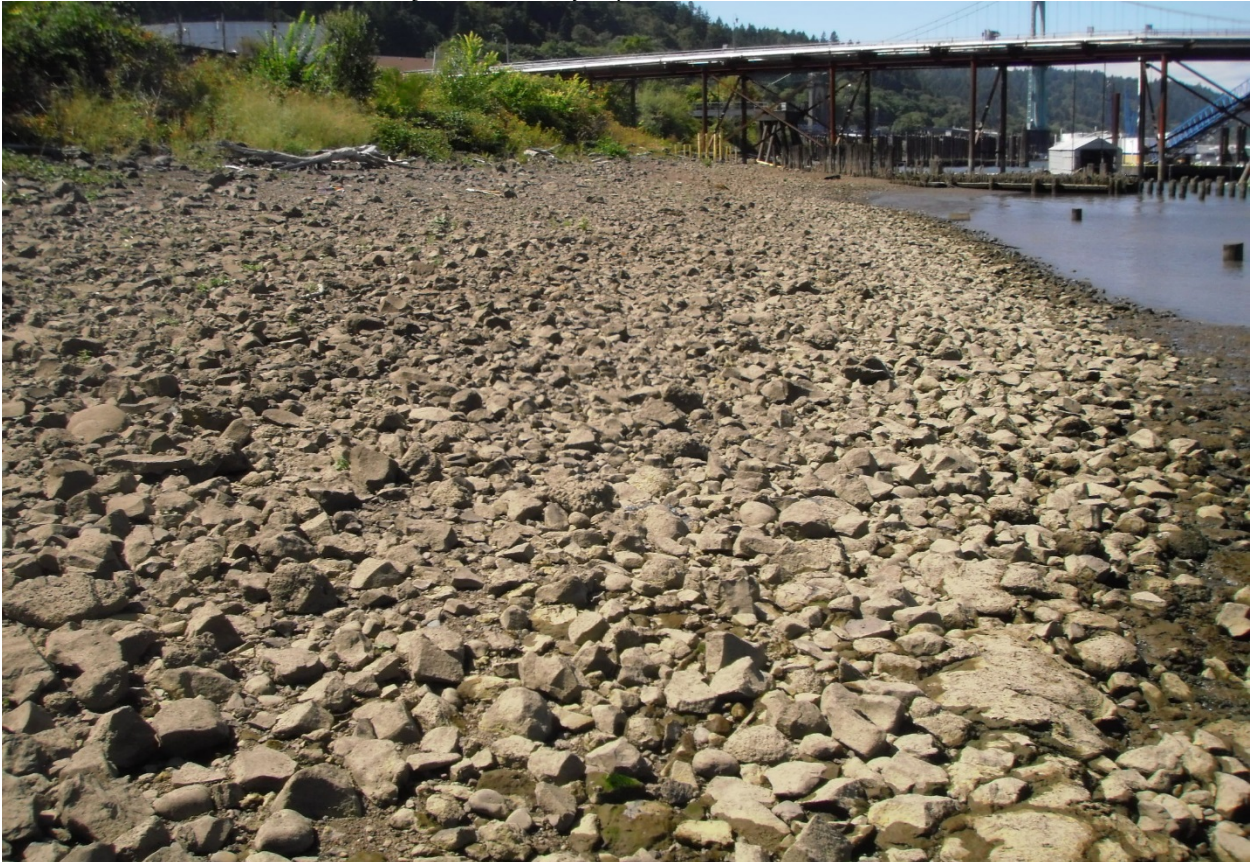
No sheen was evident in or around the cap area. Photo 3 shows the water surface and shoreline immediately downriver of the sediment cap.

Photo 3 — *Conditions immediately downriver of cap area (8/10/16):*
